CASE STUDY:

NEW YORK WATER TOWER

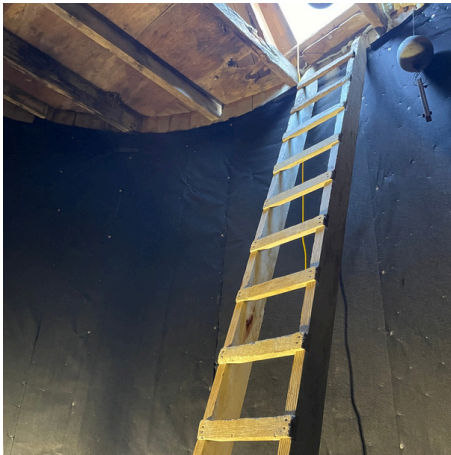
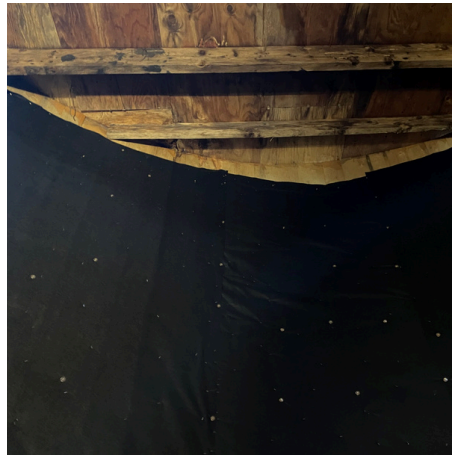
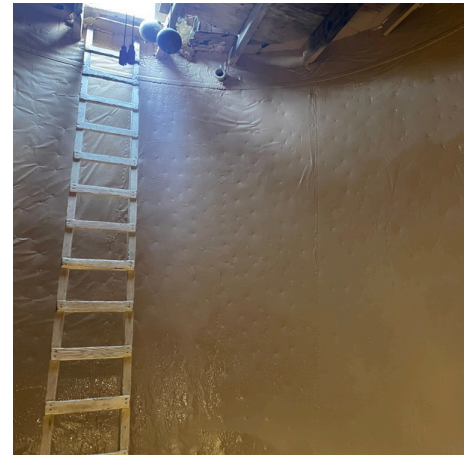
At a campground in New York, a water tower presented unique challenges. This wooden water tower, standing 30 feet high on a 15-foot hill, desperately needed rehabilitation. The tower, which provided water to the whole campground, had suffered severe damage from previous maintenance attempts, including the use of chlorine to treat the water, which had eaten away at the wood. Despite various efforts, including attempts with CIPP liners, the tower remained unstable and unusable, posing a significant challenge to its operators.

Sprayroq, in partnership with local certified partner Savy & Sons, approached the rehabilitation of this wooden structure with a strategic solution: polyurea. Polyurea was selected for its exceptional chemical resistance and flexibility, making it an ideal choice for an environment exposed to chlorine and subjected to freeze and thaw cycles. The team began by reinforcing the structure and creating a suitable application with a geotextile fabric liner, thus addressing the rotten wood, and creating a stable base for the polyurea application.

Before the application, all bolts and seams were meticulously sealed to ensure a tight barrier against water infiltration. Then, utilizing a two-step process, the team applied two 100 mil coats of polyurea. This comprehensive approach ensured thorough coverage and a durable finish, capable of withstanding the rigors of the tower's environment.
